Twin Tec

Twin Tec Model 1005 and Crane HI-4 Teardown

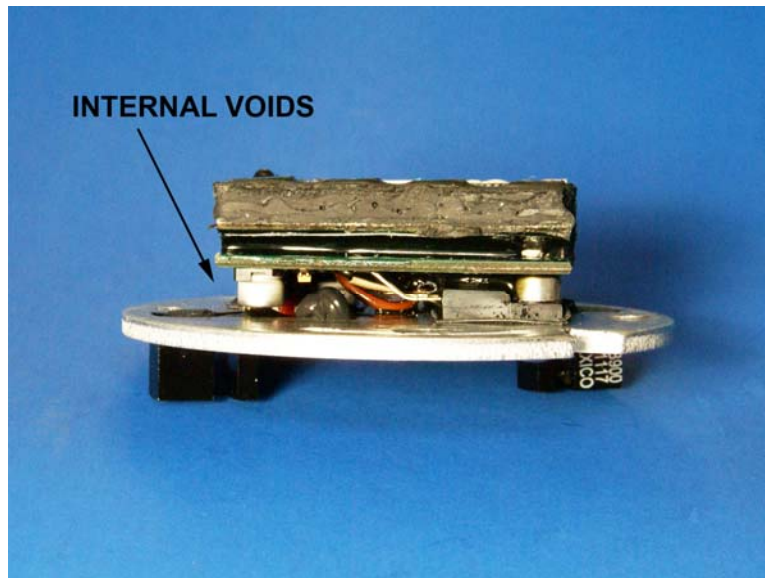
Crane HI-4 with Cover Removed Showing Internal Voids

In contrast, the Crane HI-4 has two PCBs, with components mounted on one side. The two PCBs are stacked and joined with two 5 pin connectors. These two connectors and the important coil drivers are hand soldered, significantly increasing the probability of bad solder joints and consequent product failure. The PCBs stack is mounted on a stamped aluminum plate. A molded plastic cover is then riveted to the aluminum plate. The final assembly is partially encapsulated. The resulting voids that are clearly visible in the picture below can trap moisture, resulting in corrosion and product failure.

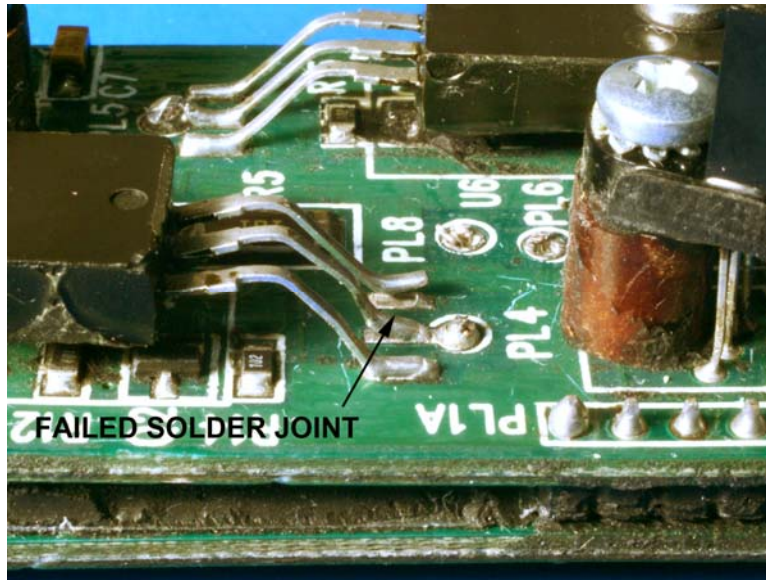
Failed Solder Joint on Crane HI-4

Another significant difference between the Model 1005 and the HI-4 is the coil driver technology. The coil driver controls ignition coil current and fires the spark. Due to the high power and voltage levels, the coil driver is the most critical part. The Model 1005 utilizes new Fairchild FGB3040CS coil drivers based on IGBT (insulated gate bipolar transistor) technology. These devices have very low power dissipation and are in reliable surface mount packages rated for operation up to 175° C (350° F). The HI-4 utilizes ST VB921ZVFI bipolar transistor coil drivers that have been discontinued by ST. The obsolete VB921ZVFI devices have significantly higher power dissipation and are only rated for operation up to 150° C (300° F). While the VB921ZVFI was intended by the manufacturer to be through-hole mounted and then flow soldered, in the HI-4 the leads are crudely bent down on the board and hand soldered. Failure of one of these solder joints is common and results in one cylinder not firing. In fact, the HI-4 unit used for this teardown had failed due to a bad solder joint in this area.
